**Deep Energy Envelope Upgrades
Using Retrofit Insulated Panels**

**New York State Energy
Research & Development Authority
17 Columbia Circle
Albany, NY 12203**

PON 24003 Final Report

April 15, 2015

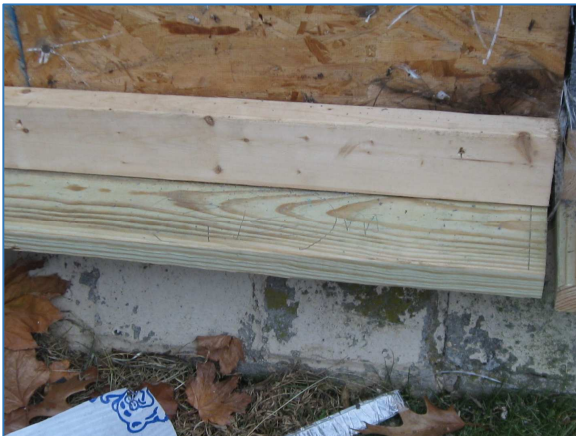
The existing rear foundation masonry had been installed with a sloped profile at the outside grade in an attempt at dispelling rainwater from the foundation. Because of this, the ledger that carries the first retrofit panel and provides its edge seal had to be installed inverted to accommodate the condition and maximize the wall coverage. Figure 13 outlines the standard detail for ledger attachment.

The ledger also serves as an insect guard at the panel bottom after the foam is adhered to it and the OSB is fastened to its edge. Figure 14 shows that the ledger at the flared foundation was supported from a 2x4 above the ledger rather than below. This required an additional groove to be cut in the foam panel, doubling the cut labor at this location, Figure 15.

Figure 14. Inverted Ledger to Accommodate Sloped Foundation Wall Beneath

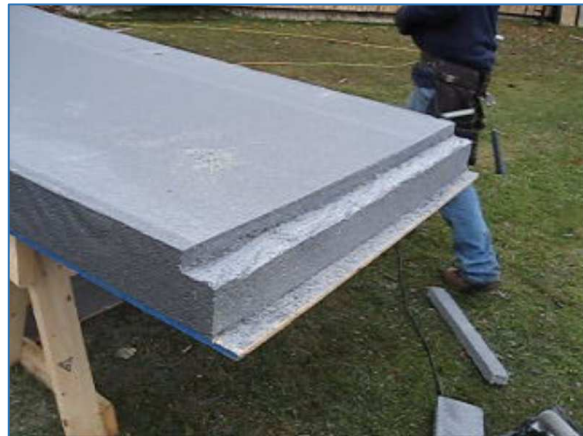
Figure 15. Panel Edge Grooves for Inverted Ledger

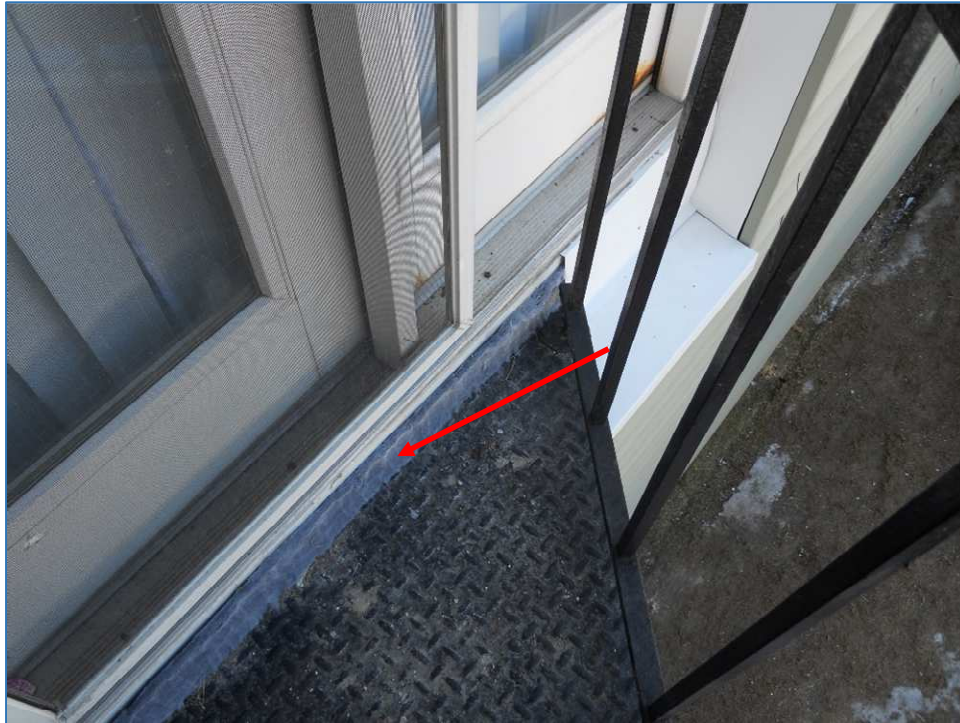
Aerogel fabric was installed behind the rear stair landings underneath the patio doors to provide some additional thermal resistance and an air seal because the stair assembly could not be removed for access. The 10 mm thick fabric provides a thermal resistance of R-4 and is vapor permeable, but wind resistant, Figure 17. The material was installed at the band boards behind the rim of the metal stair landing and sealed around the lag bolts supporting the stair assembly, Figure. 18.

Figure 18. Aerogel Fabric between Stair Landing and Band Board below Door

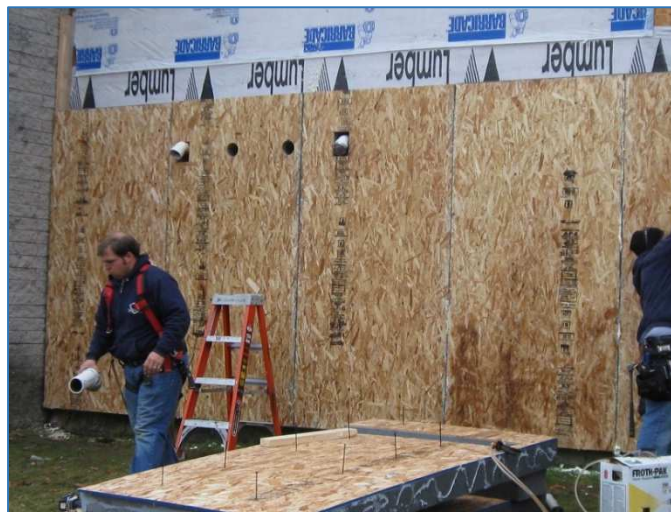
Figure 19. Application of Panel-to-Panel Adhesive

Optimum panel to panel adhesion is shown as two continuous straight beads of sealant (approximately 3/8 in. thickness) for most applications shown in the Installation Guide. It seems that the location of the adhesive beads at the panel's edge may be more critical than what was stressed by the trainers, based on the initial results testing the building's air seal. The spray foam visible at the side of the panel staged on saw horses in Figure 19 (horizontal panel in foreground) shows what may have been a typical panel-to-panel application of SPF that does not appear to be continuous. How long this panel stayed on the saw horses prior to setting the panel in place is another unknown. For effectiveness, the SPF sealant must not be allowed to dry prior to installation of the panel; otherwise the sealant may act as a spacer between the panels, causing an unintended air leakage gap. Scrutiny of the graphic details in the Installation Guide indicates that a single 3/8-inch bead of adhesive is required in proximity to the OSB edges of each abutting panel in order to effect an air seal.

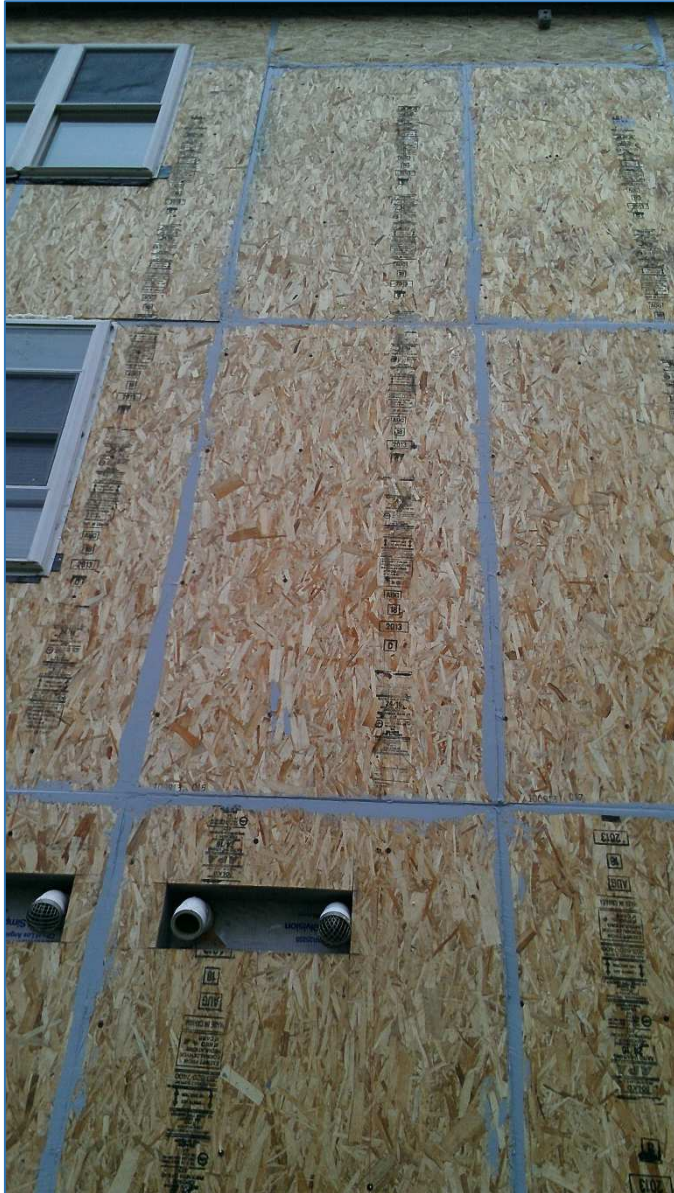
Figure 20. Large Rectangular Cutouts to Accommodate Water Heater Direct Vent Piping

were 1/8 in. to 3/16 in. out of plane (referred to by the trade as “saw tothing”). The crew believed they could cover these irregularities with the vinyl cladding. A SIPA trainer that was on site at the time was concerned about the integrity of the air seal at these out-of-plane joints, and advised that all edges be sealed with mastic applied by trowel. (Figure 20, previous.)

The solution for a bowed retrofit insulated panel is to fasten the panel to the wall from the bottom up using double the number of screws required and tighten these incrementally moving across the panel width. The extra screws can be removed and re-used after installation and the holes filled with foam. The six-inch panels tended to bow in the middle of their length which is said to happen when OSB absorbs moisture. Panels were properly stored off the ground and covered before installation. OSB will take on moisture when exposed to high humidity conditions, thus the bowing may have resulted from atmospheric conditions. Daily average exterior relative humidity ranged from 53% to 100% during the month of December 2013¹³, when the phenomena was observed.

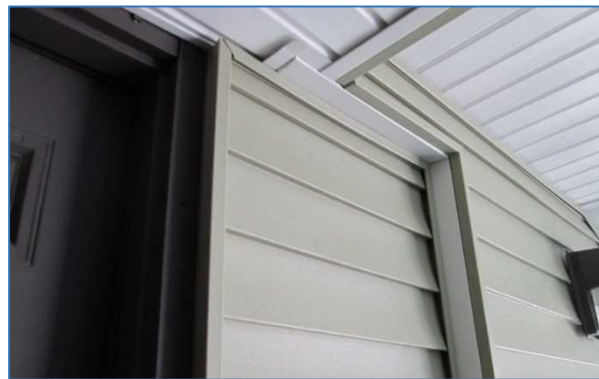
Typically, an increase in wall thermal performance would be achieved using one consistent panel thickness to achieve the R-value target. In this case, a weighted average wall R-value approach was necessitated by two facts of this demonstration building – the desire to retain the aesthetic of the split-face CMU wall and not cover it with insulated panels and retaining egress at the front stairways and landings. Figure 21 shows the transition from a 4 in. to a 2 in. panel around the door at left. These reductions in retrofit panel thickness were required to maintain minimum clearances at the landings adjacent to the three doorways accessing each section of the building. This use highlights the flexibility of the method to accommodate the many architectural nuances in existing structures.

Figure 21. Retrofit Panel Step-Down in Thickness at Entry Landings

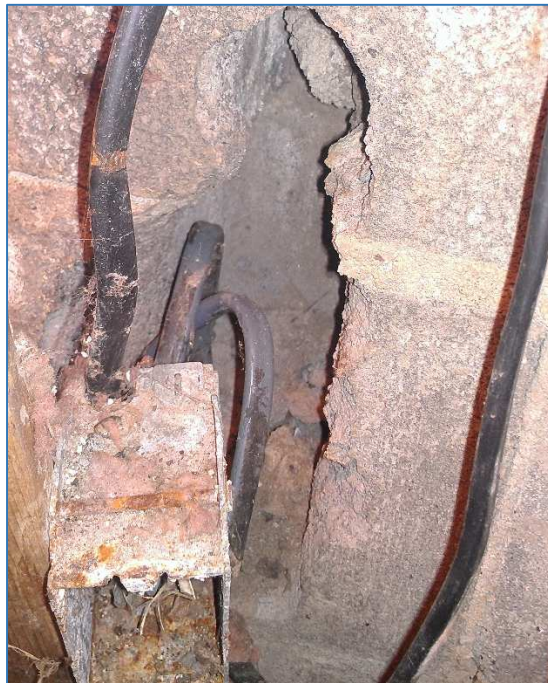
The contribution to air leakage by stack effect became apparent during the final blower door tests where it was noted that basements articulate directly with second levels via a common stairwell and possible hidden chimney(s) containing pipes for the retrofitted fire sprinkler system. CMU walls were capped in the attic as per the scope of work for the attic air seal, however, there are likely other undetermined leakage pathways through the CMU wall. Visual inspection from the abandoned basement units indicated that the CMU blocks had been penetrated by receptacle boxes installed in the party wall of all units, as per Figure 22.

Figure 22. Abandoned Basement Receptacle at CMU Wall

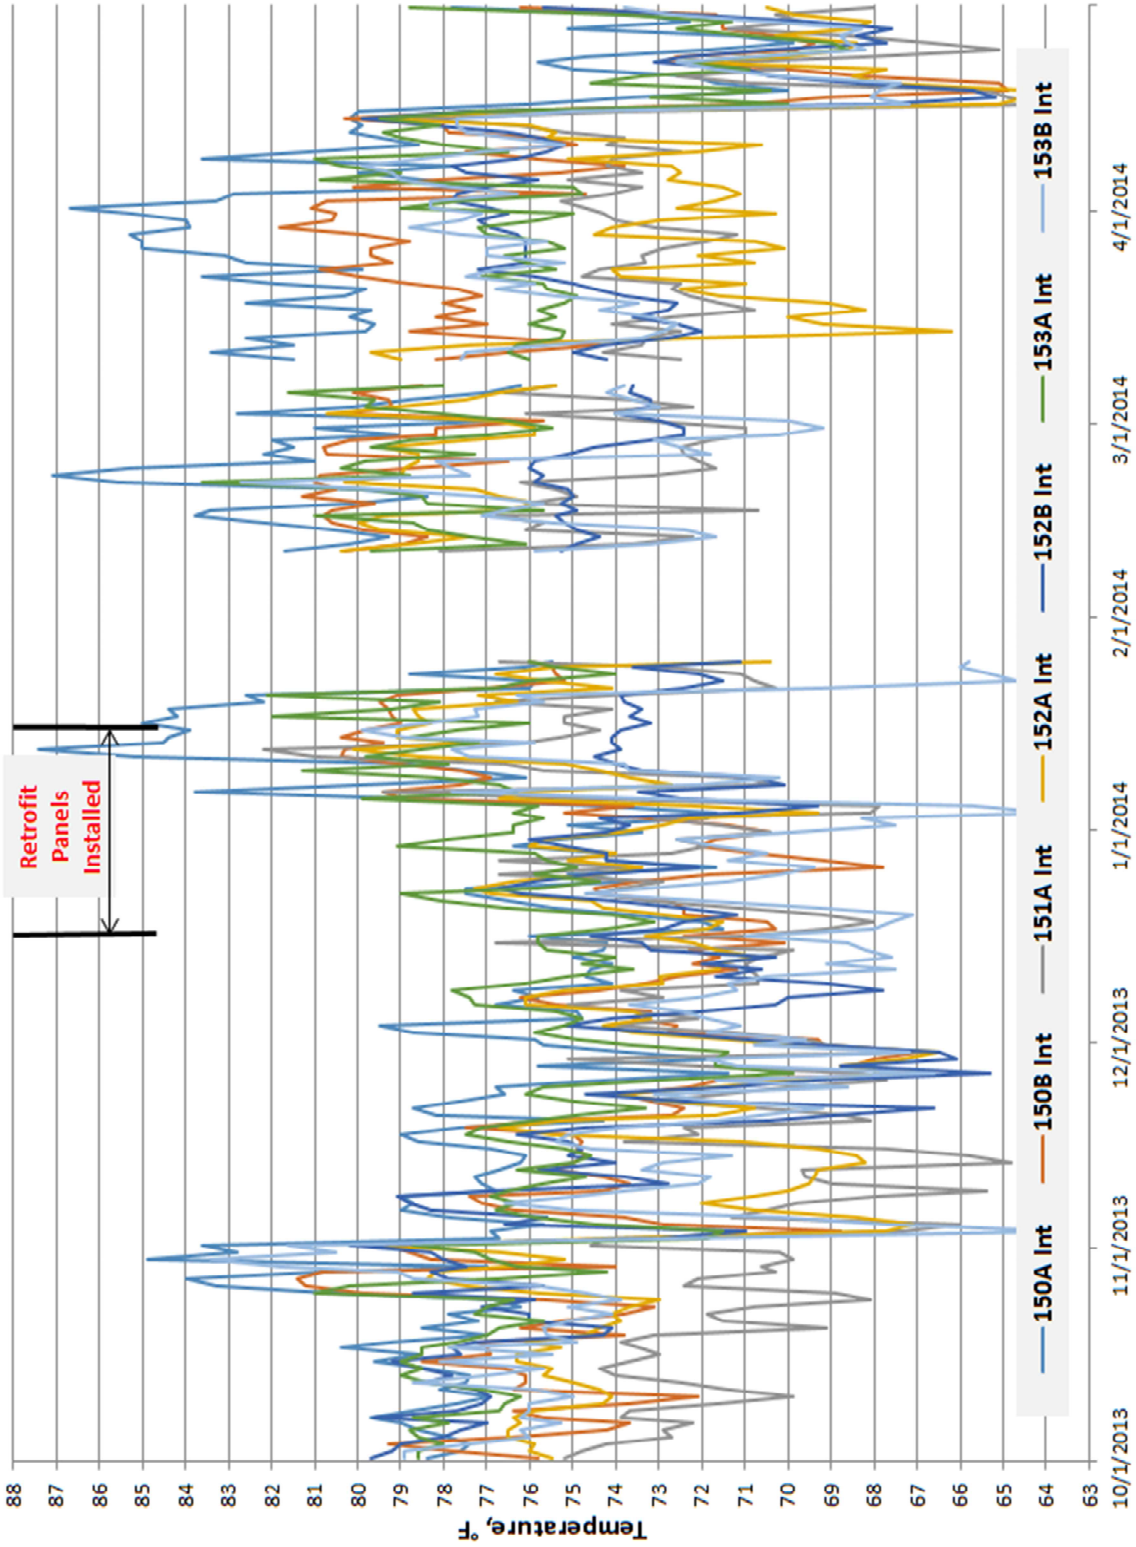
results however, do not compare to the one month's HDD-normalized actual usage shown in Table 6 despite inputting the measured building envelope leakage of 6.4 CFM50. As indicated in Table 7, the modeled energy savings after retrofit panels and attic seal/insulation was installed is about 31% versus the actual savings of 21% (natural gas which accounts for the primary energy usage in the building). These results indicate that the usage patterns of the units do not conform well to the models represented by the simulations. Two behaviors that have been noted that would confirm this are the high temperatures that are sustained within the units and the fact that air leakage via unlatched windows is probable. A few occupants mentioned that they open a window or rear door in the winter without turning off the heat. These factors complicate the alignment of the predictive data with the actual measurements in these buildings. In fact, the ten degree daily interior temperature swings that have been recorded coupled with the inaccessible location of the hydronic baseboard controls (behind bulky furniture) suggest that winter temperature control is via introduction of outside (cold) air after overheating occurs (Figure 23).

Figure 23. Indoor Temperature – Winter 2013/2014
