Moisture Managed High-R
Envelopes

Attic Retrofits Using Nail-Base Insulated Panels

January 2018

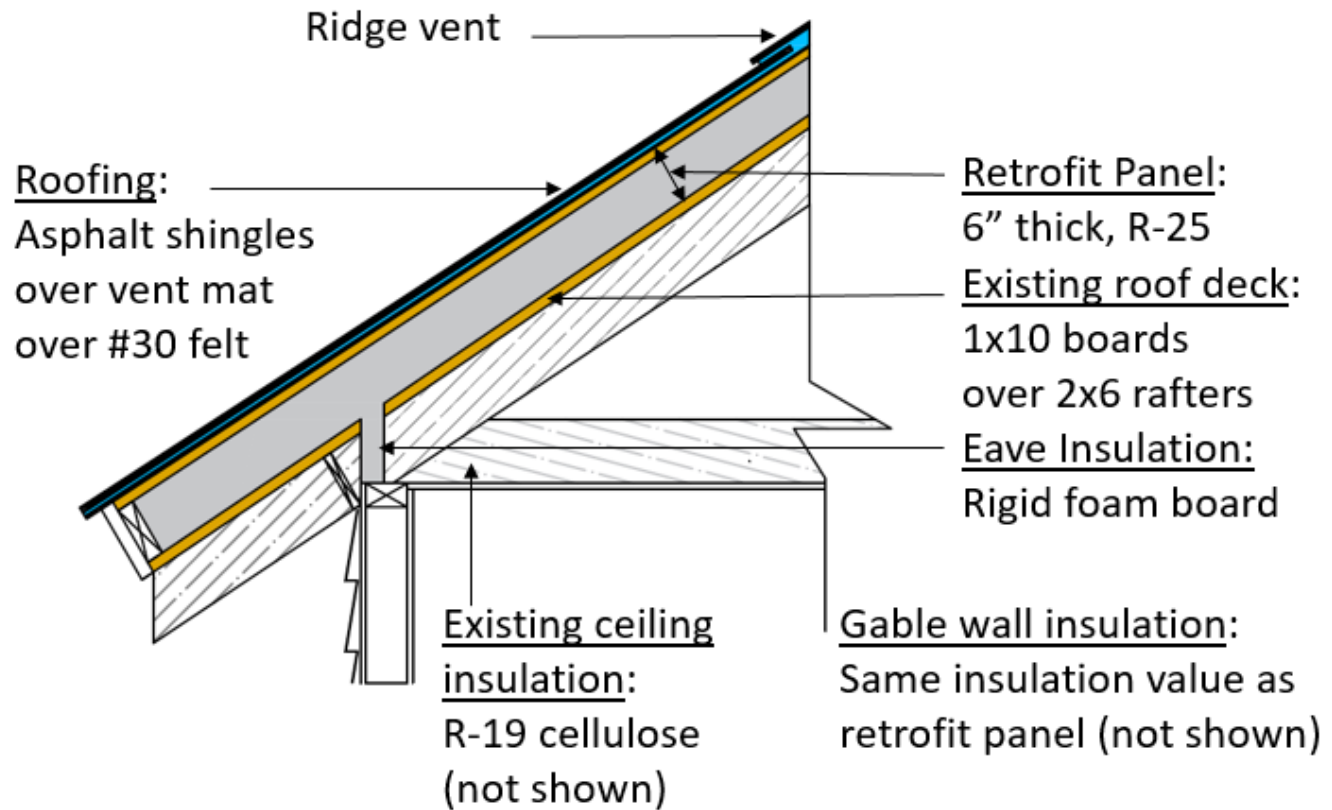
Georgia Retrofit Design

Design Solution – GA

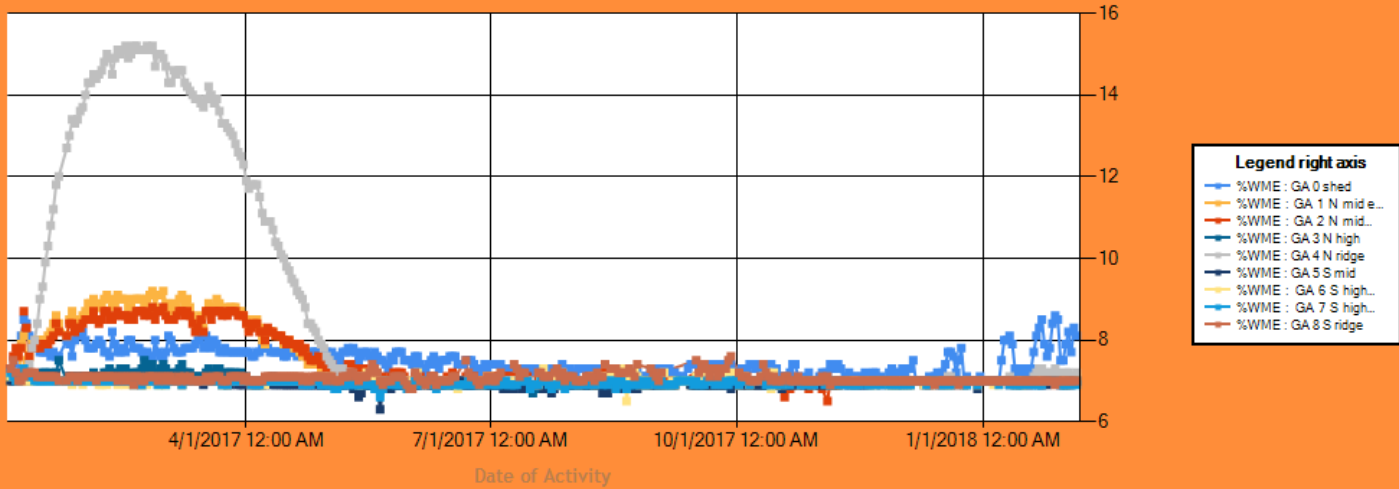
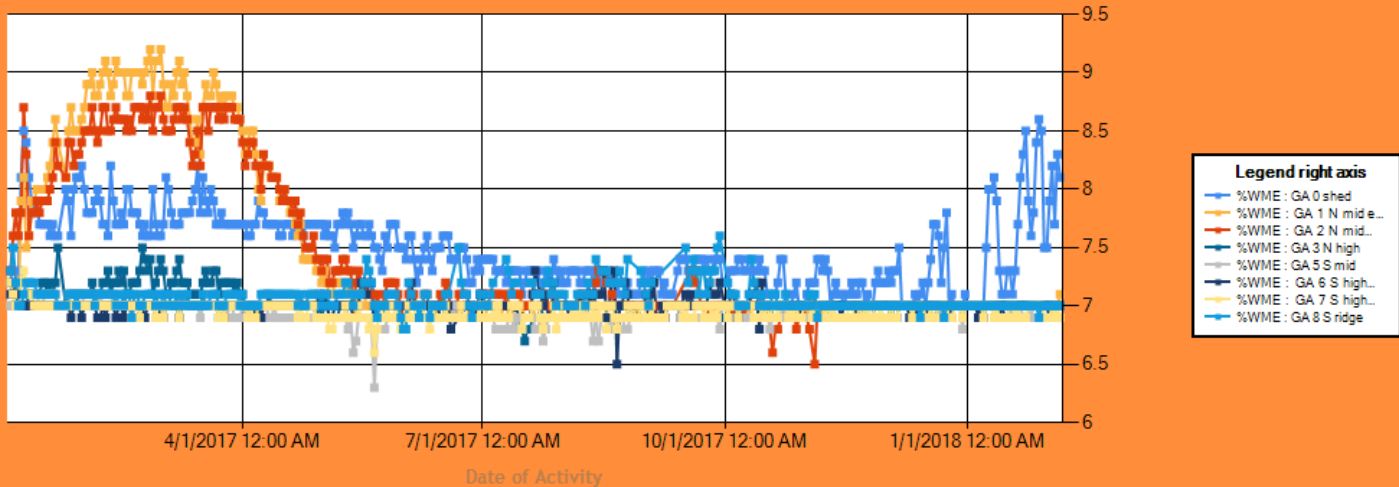
GA Data – MC at Retrofit Panel

Extended Data: Jan 2017 – Feb 2018

Note: lower graph is without the outlier

Average Sensor Values from 1/1/2017 12:00:00 AM to 2/6/2018 12:00:00 AM using daily averages

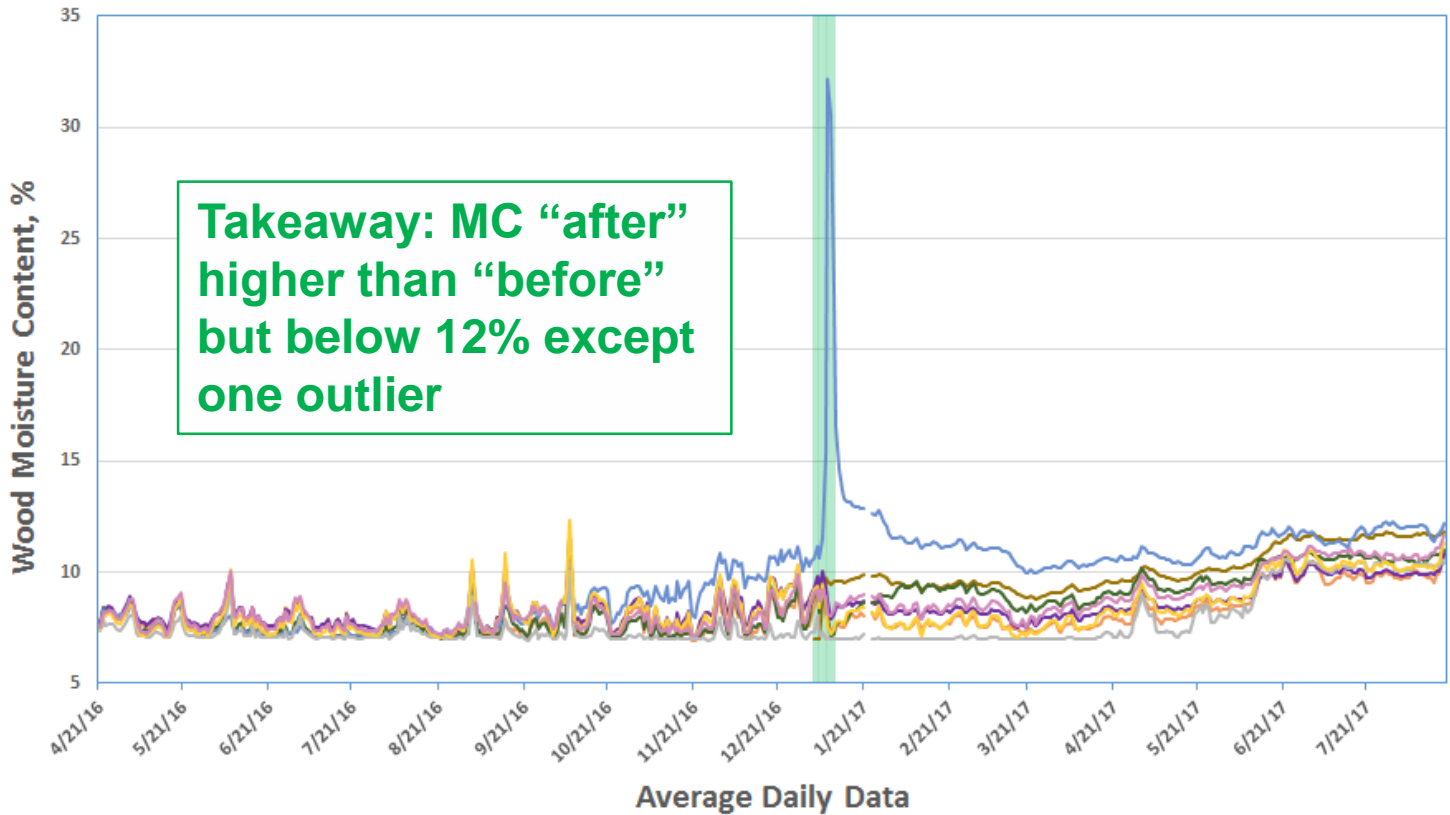
GA Data – MC at Existing Deck/Framing

MC at original roof deck and rafters (sensors in attic)

Note: one outlier, at deck, low near ceiling, rained that night

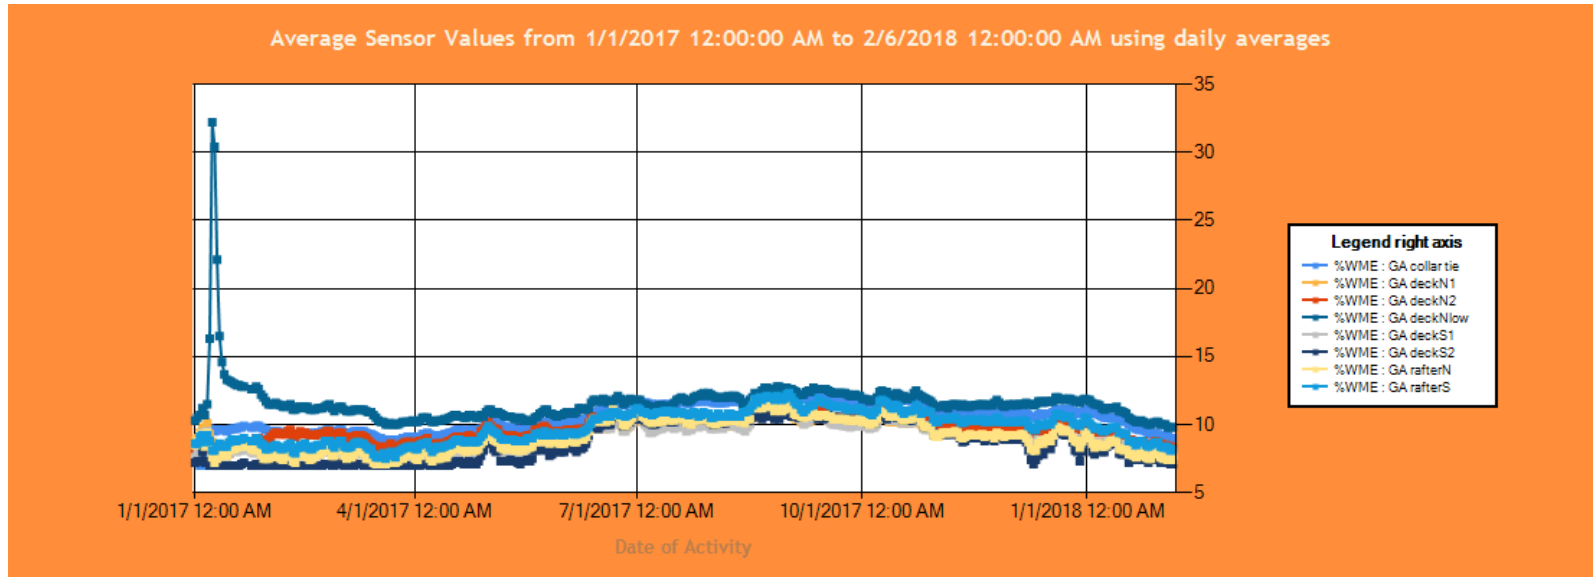
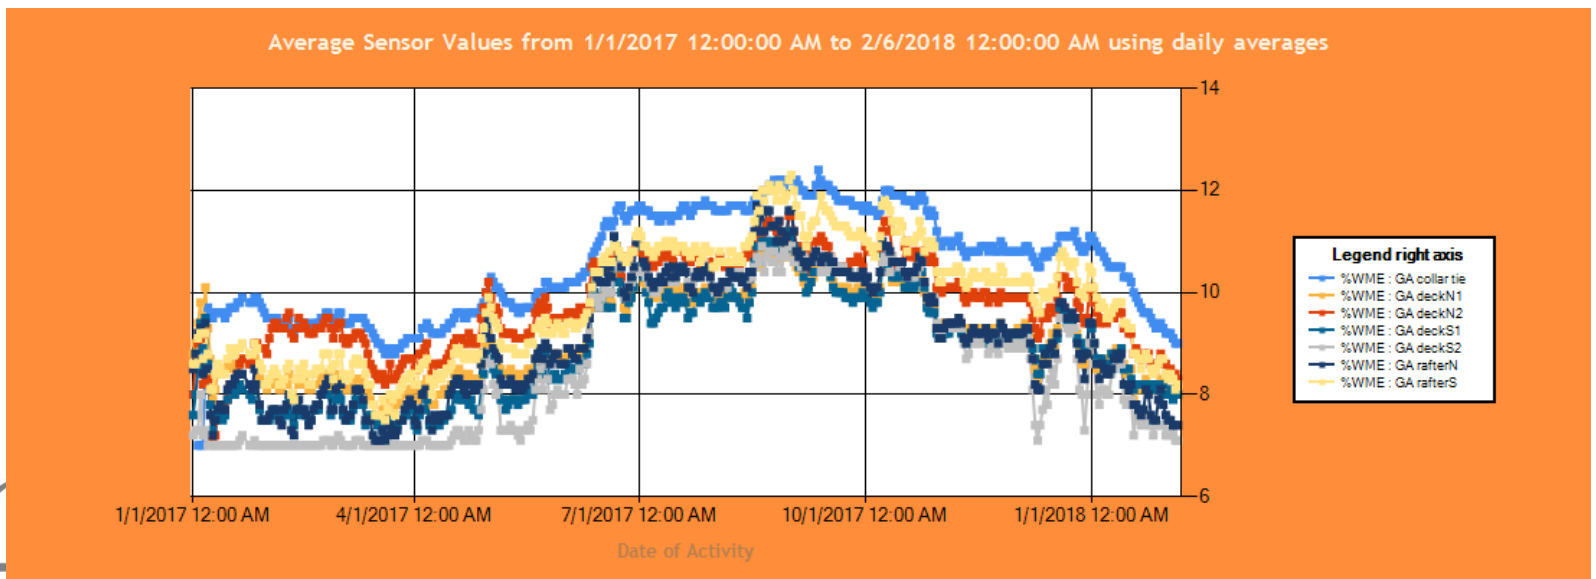
GA Data – MC at Existing Deck/Framing

Extended Data: Jan 2017 – Feb 2018

Note: lower graph is without the outlier

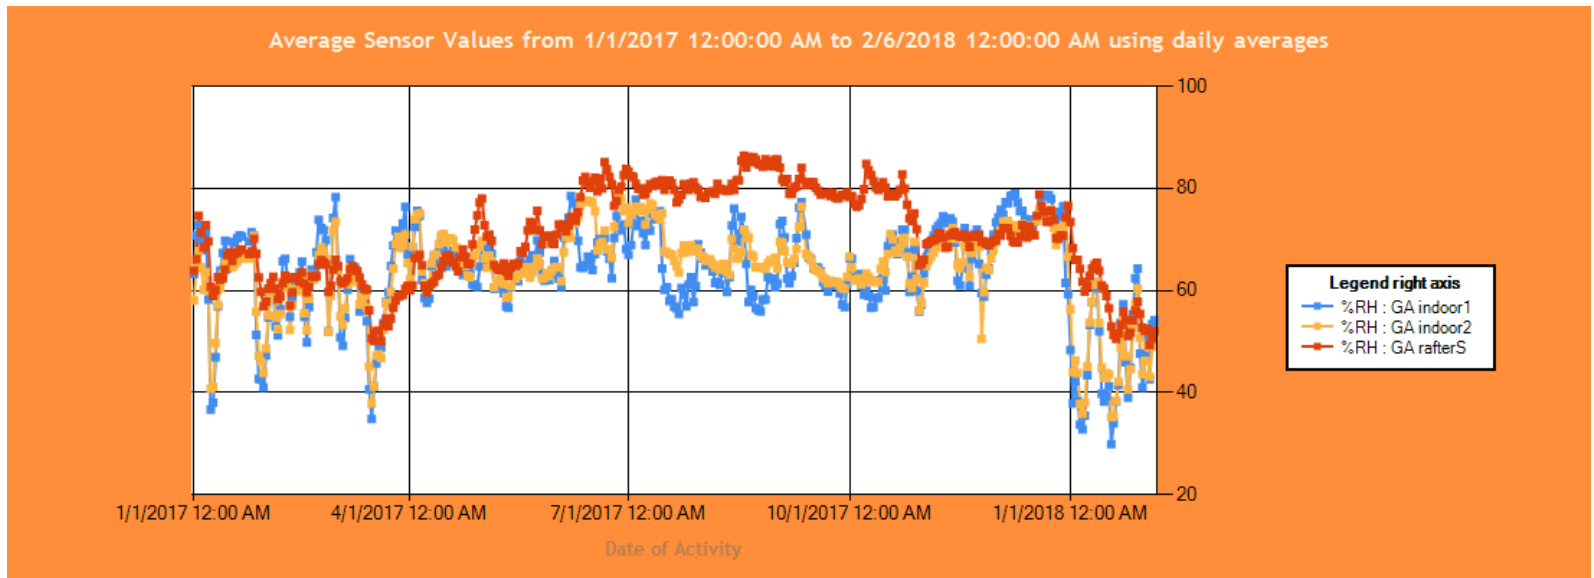
GA Data – RH Conditions

Extended Data: Jan 2017 – Feb 2018

Note: attic RH indicated by red line

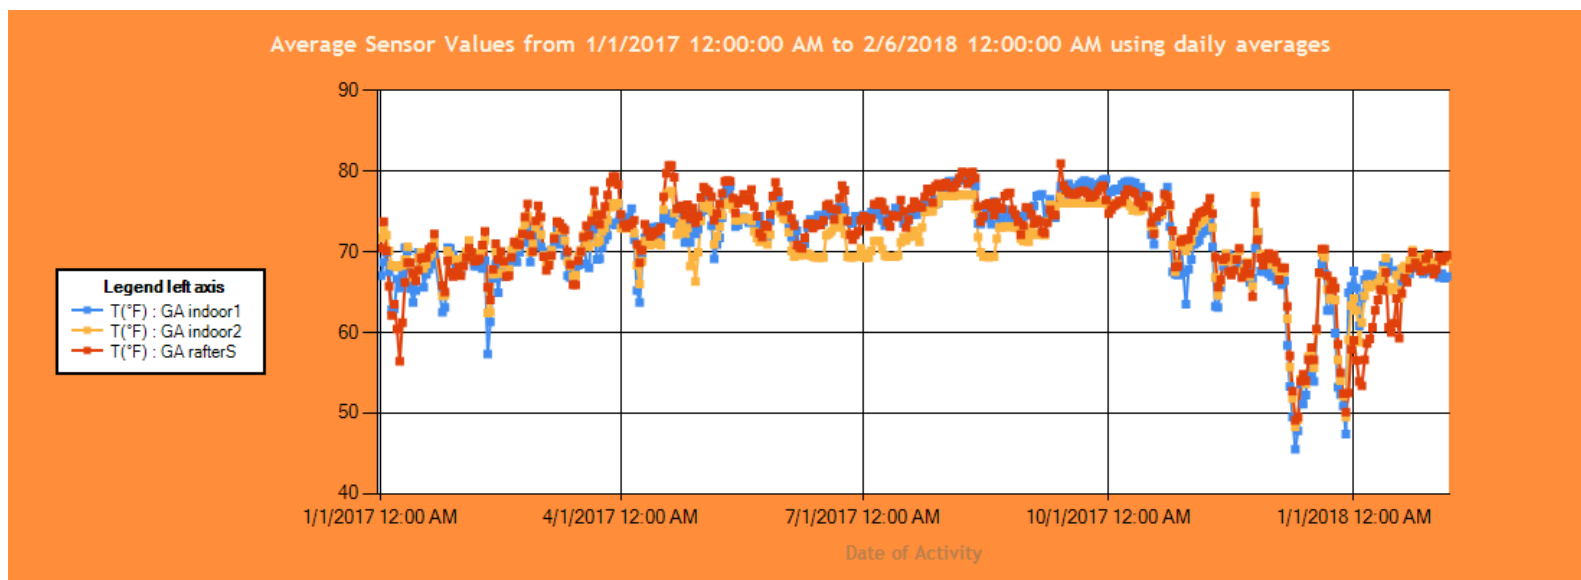
GA Data – T Conditions

Extended Data: Jan 2017 – Feb 2018

Note: attic T indicated by red line

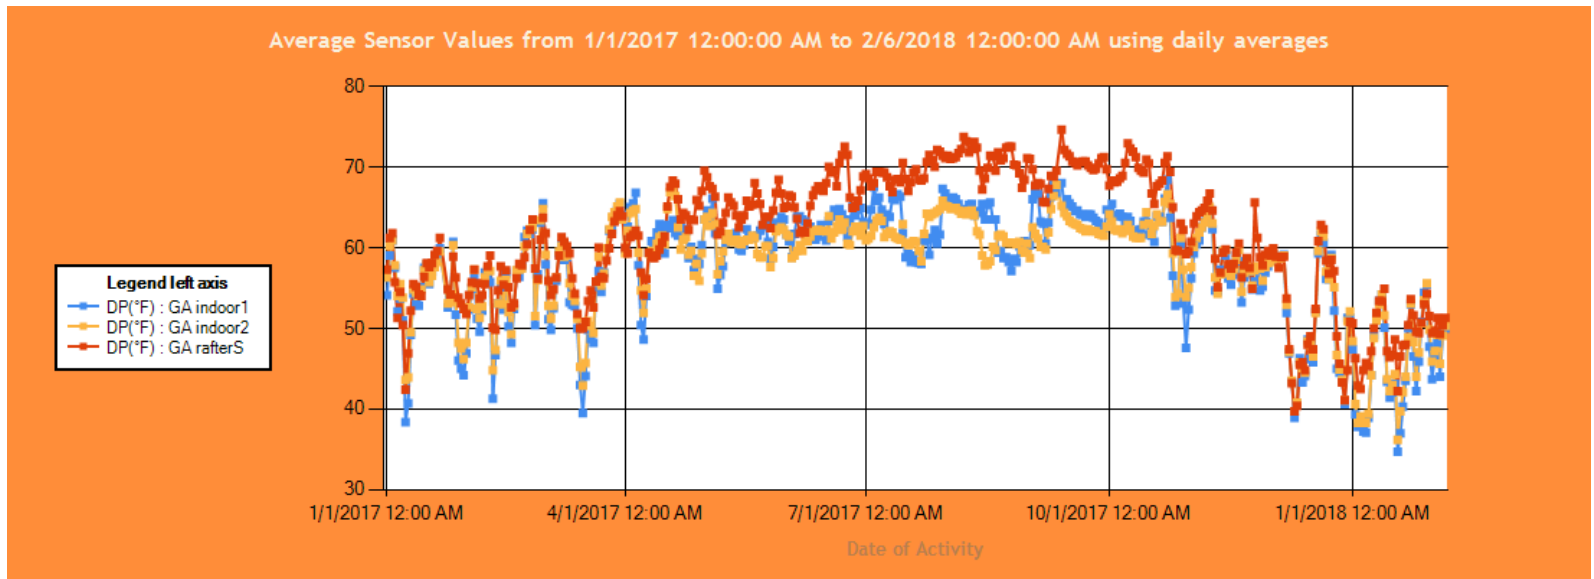
GA Data – DP Conditions

Extended Data: Jan 2017 – Feb 2018

Note: attic DPT indicated by red line

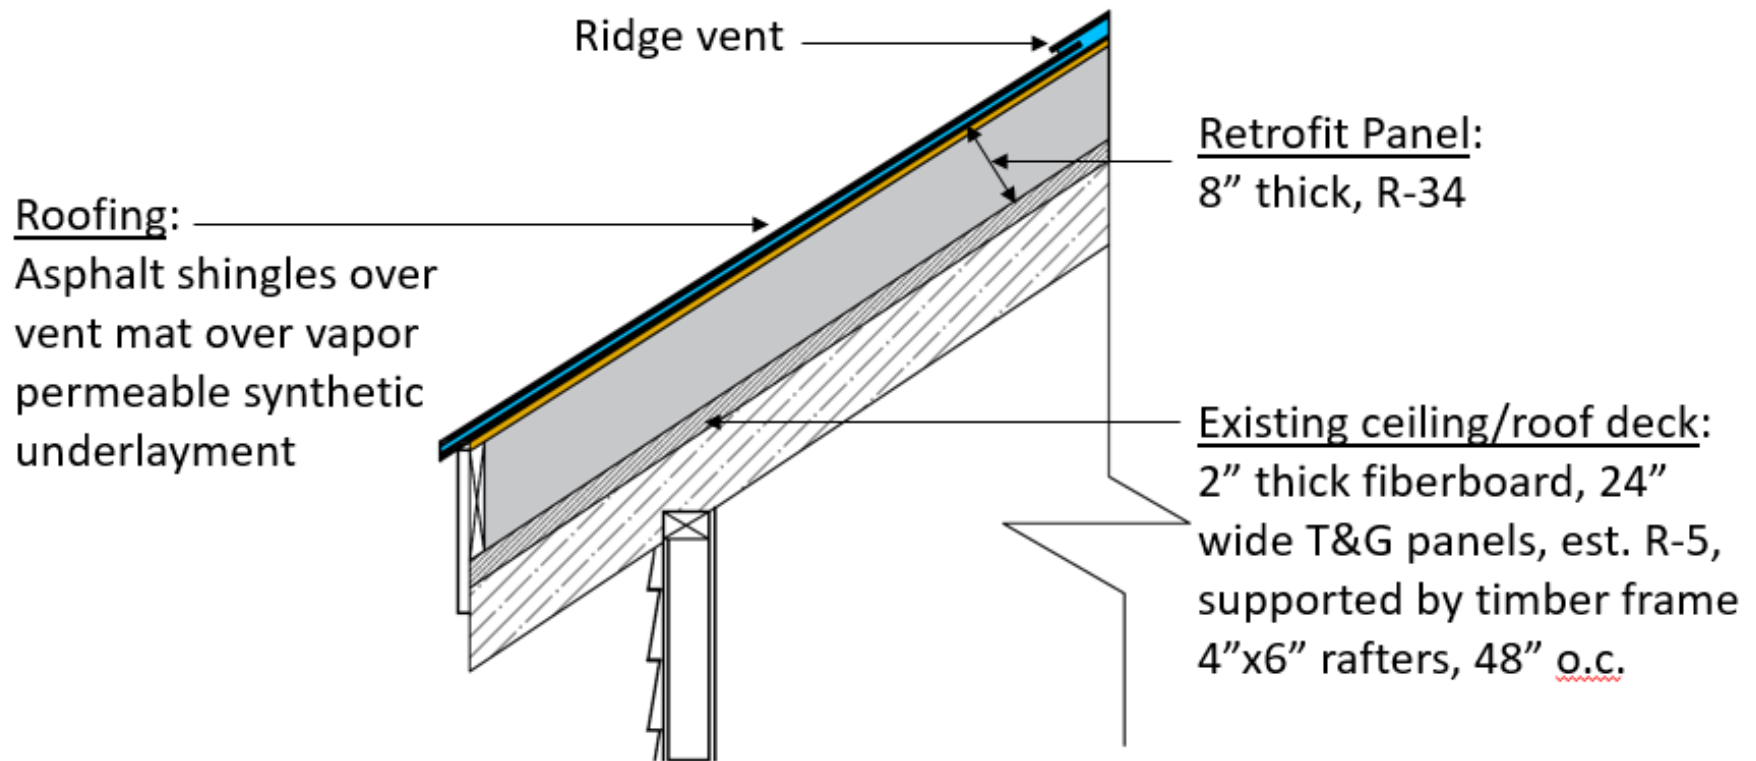
Michigan Main Roof Retrofit Design

Design Solution – MI

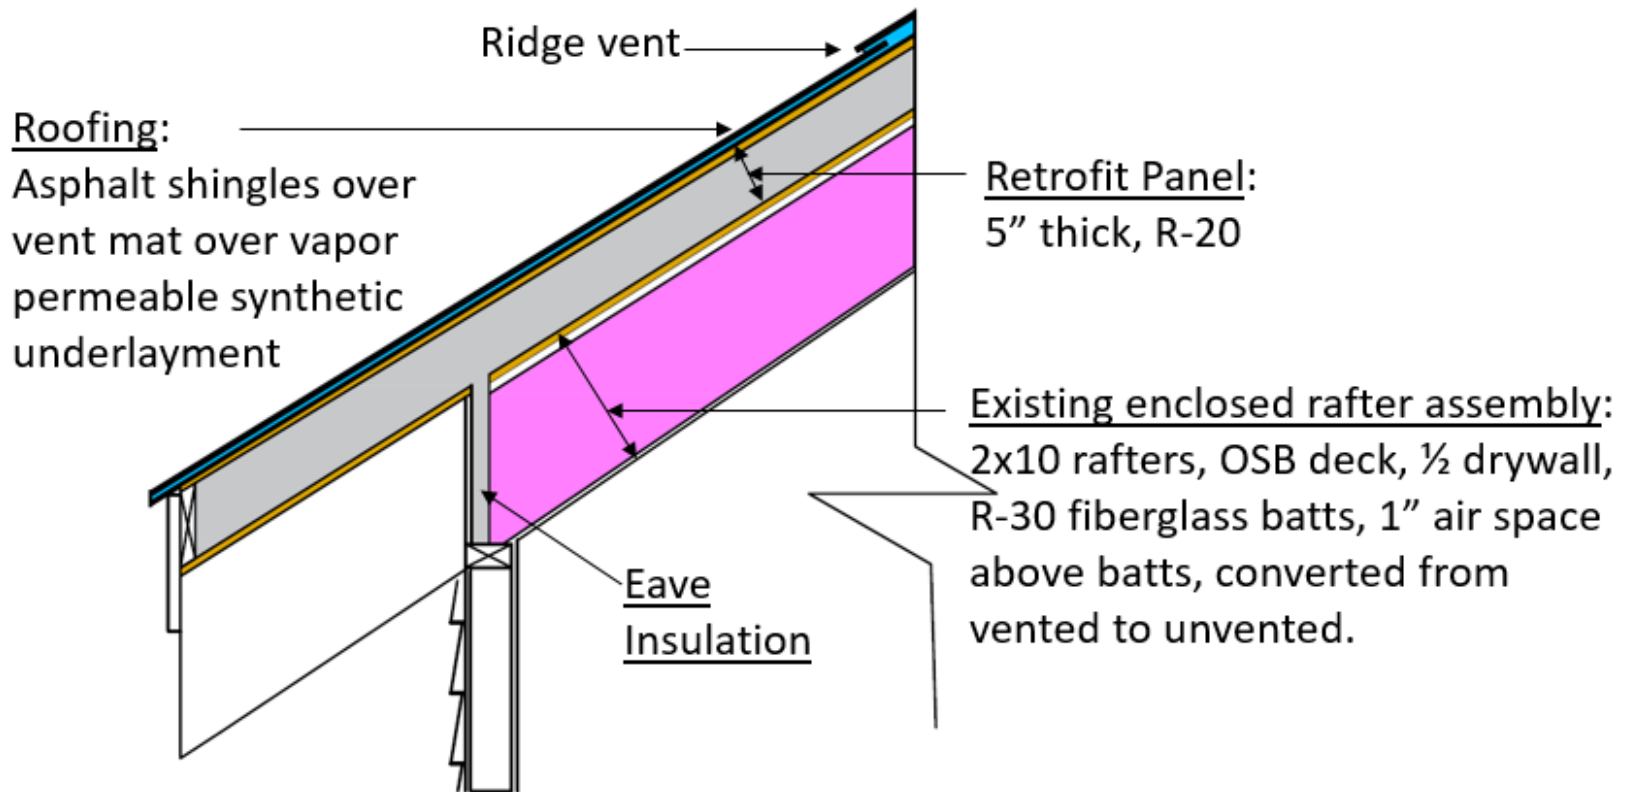
Michigan Addition Roof Retrofit Design

Design Solution – MI

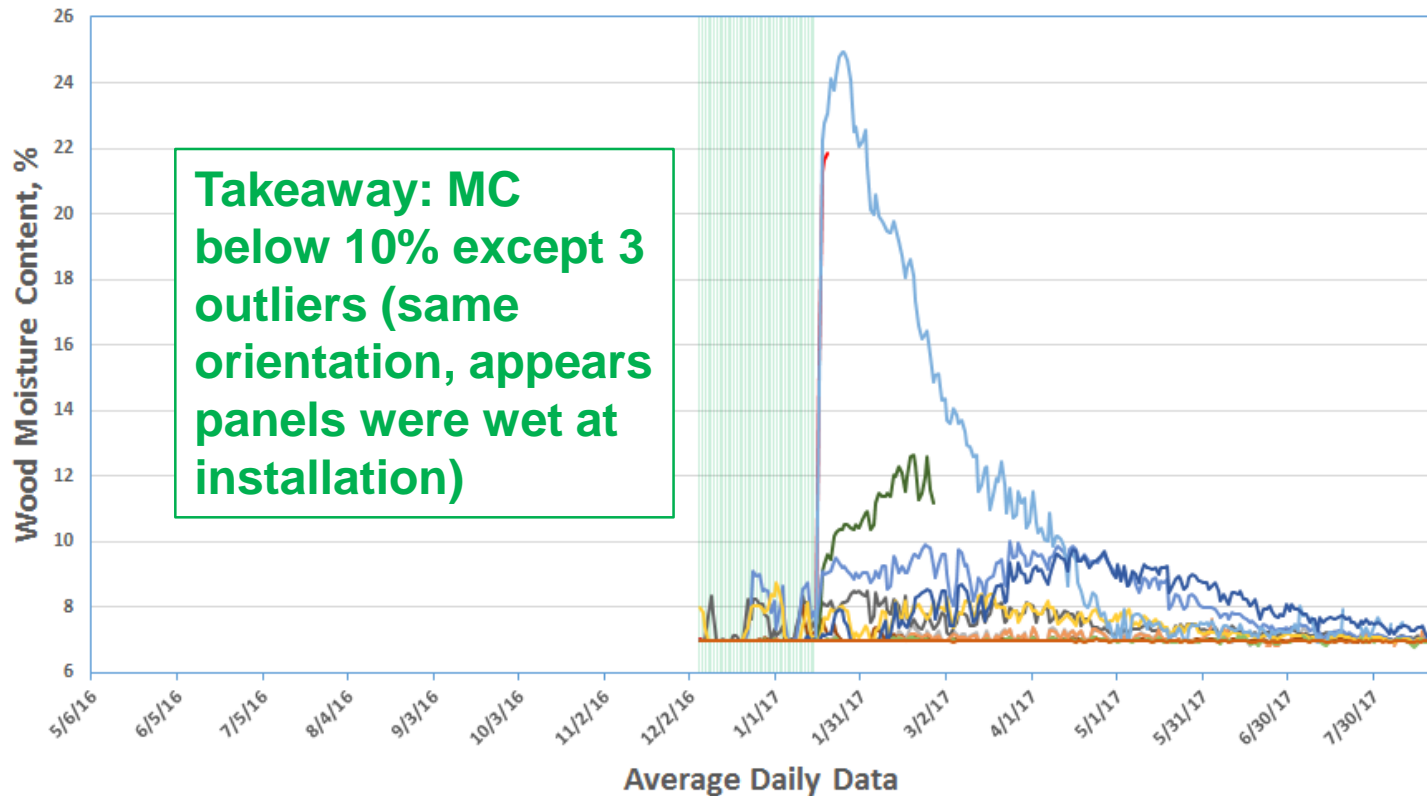
MI Data – MC at Retrofit Panel

MC at retrofit panels

Note: 3 outliers (MI 10/11/12 S), same orientation, appears panels were wet at installation

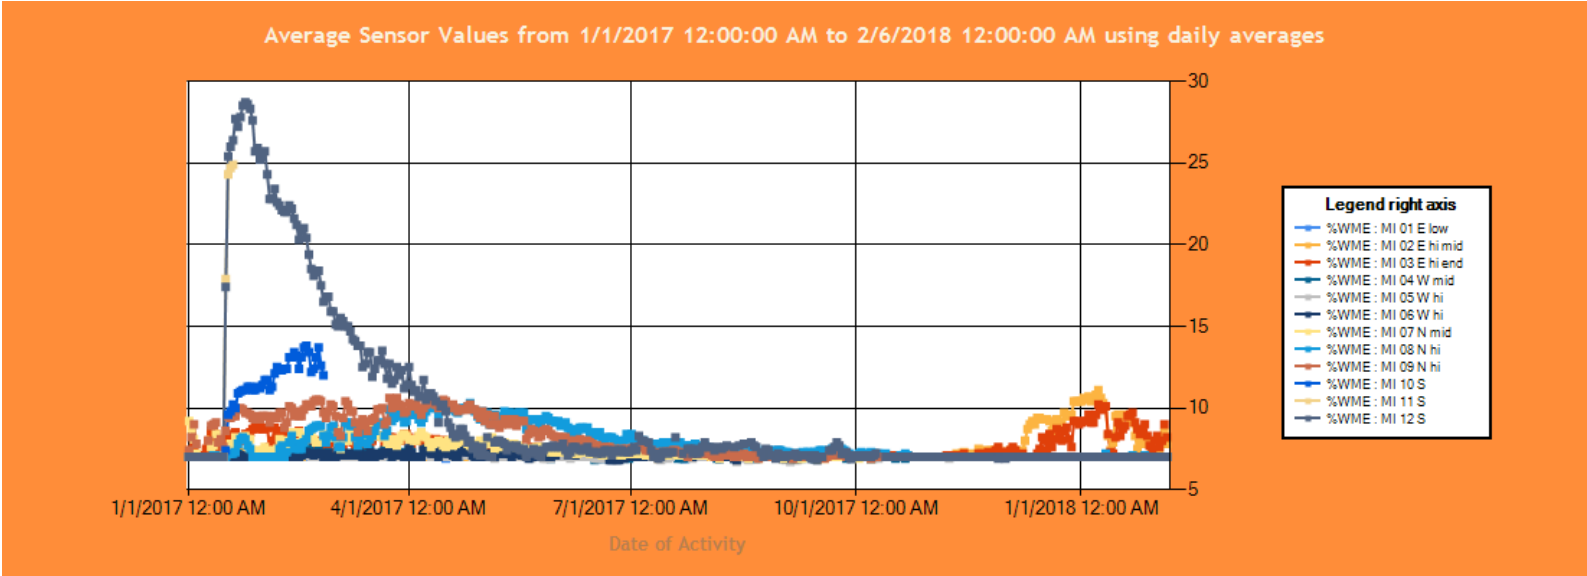
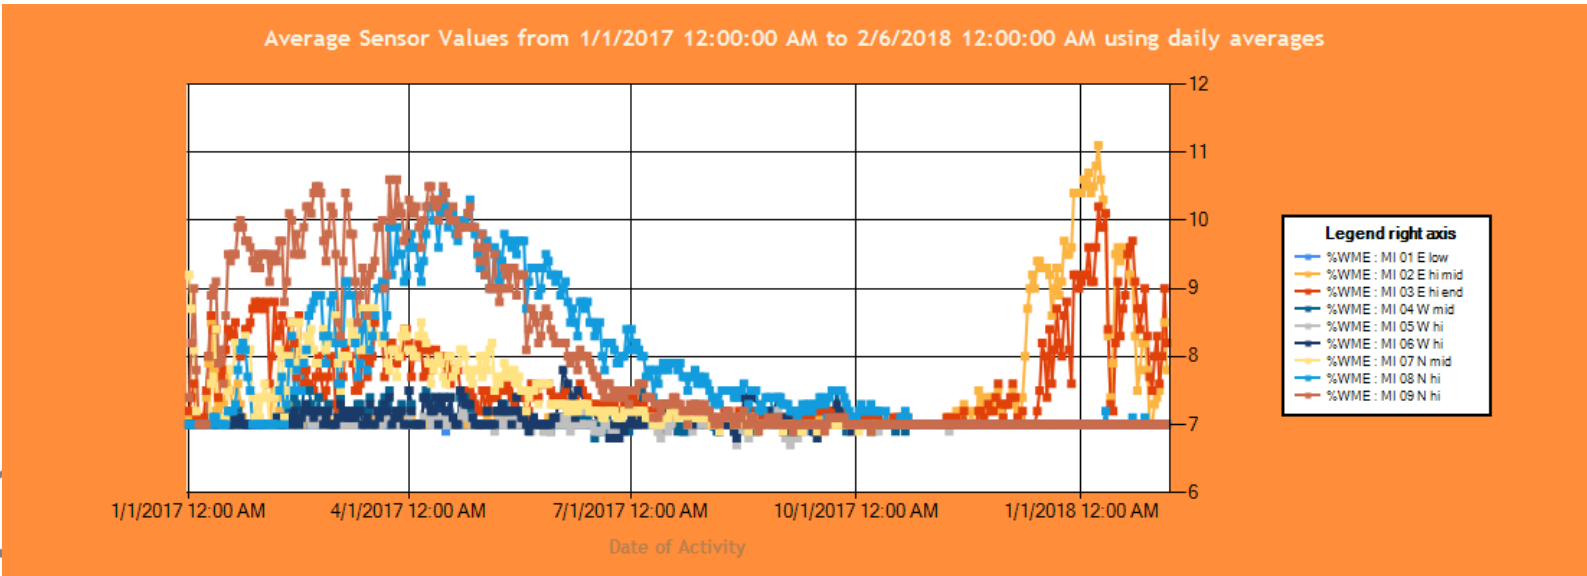
MI Data – MC at Retrofit Panel

Extended Data: Jan 2017 – Feb 2018

Note: lower graph is without the outliers

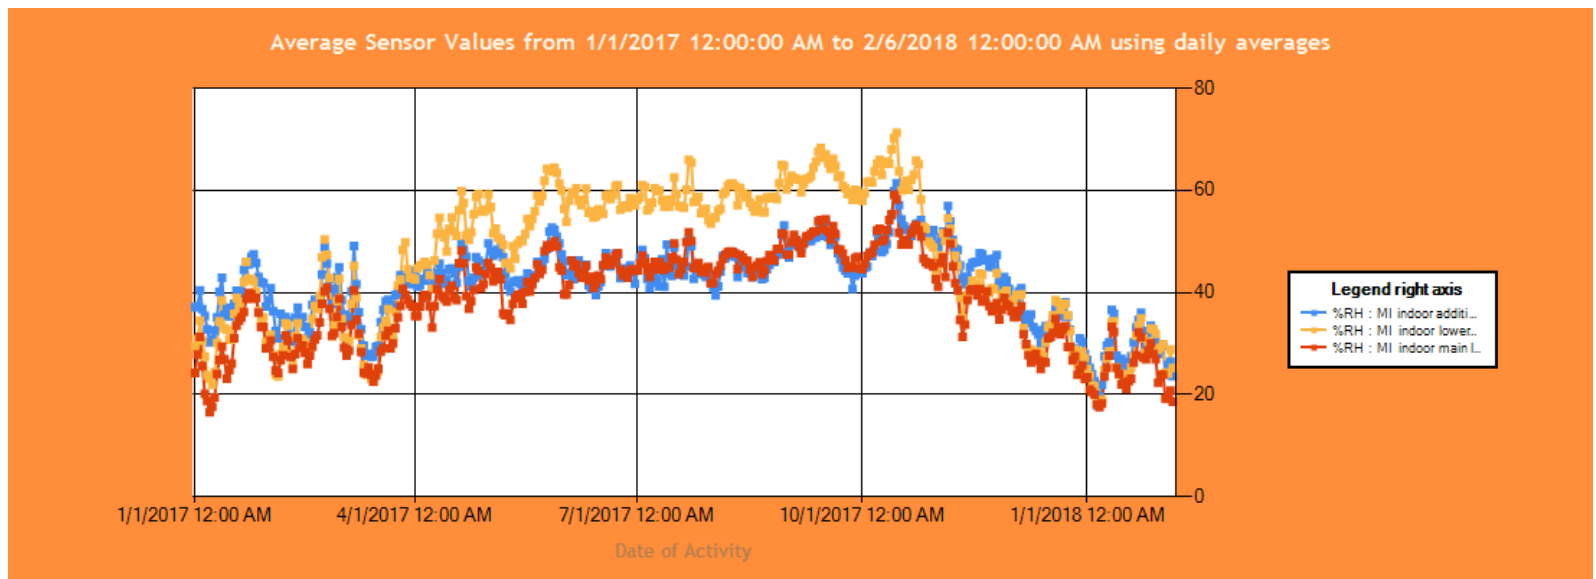
MI Data – RH conditions

Extended Data: Jan 2017 – Feb 2018
