**Deep Energy Envelope Upgrades
Using Retrofit Insulated Panels**

**New York State Energy
Research & Development Authority
17 Columbia Circle
Albany, NY 12203**

PON 24003 Final Report

April 15, 2015

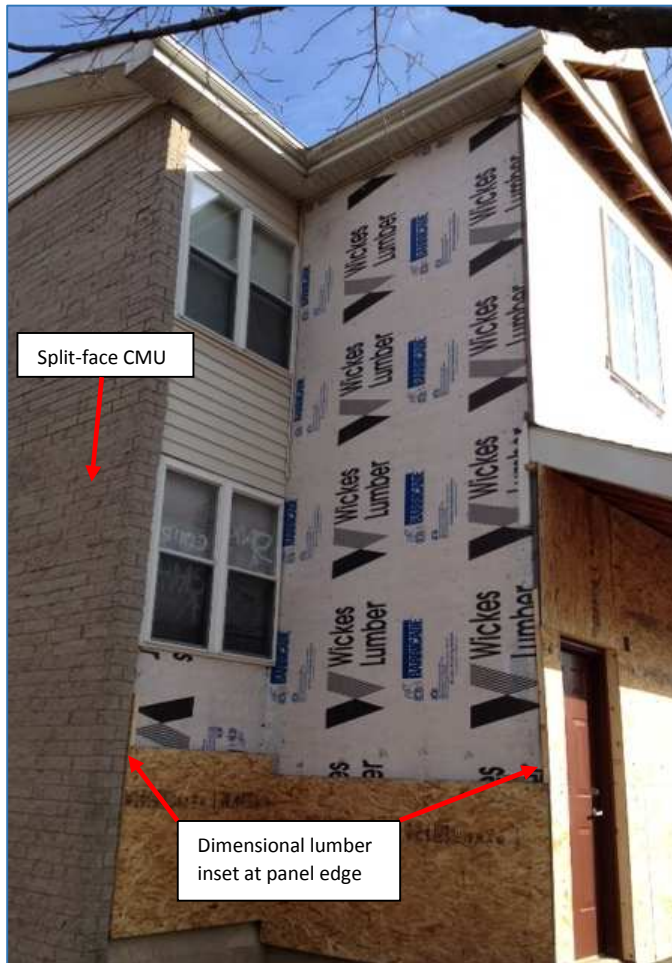
Figure 8. West Northwest Exposure, Left Side Elevation

Retrofit insulated panel to panel connections include double beads of mastic or spray polyurethane foam (SPF) for air tightness at the panel edges. Panel edges at building outside corners and soffits are "sealed" with dimensional lumber that is recessed into a foam cutout, adhered to the foam and OSB, and nailed in place through the OSB lip, Figure 8 and Figure 9.

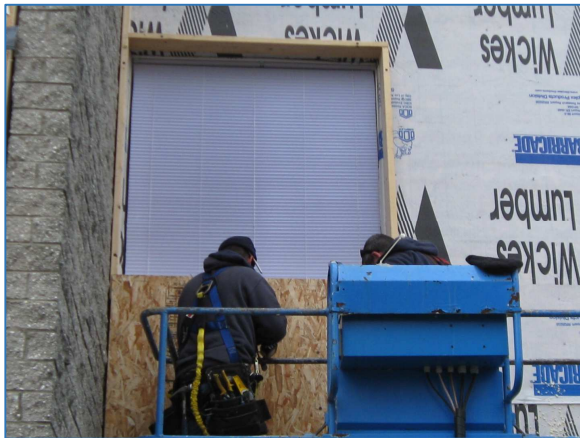
Figure 11. Window Jamb Extensions Were Formed with 2x6s Applied from the Exterior

Twinned windows were removed from the exterior as one piece and set aside. A 2x6 box frame was installed directly to the existing window frame with seven and one-half inch SIPs screws inserted into predrilled holes in the 2x6s. These window jamb extensions also served as the retrofit panel edge blocking. The edge foam in the retrofit panels was then cut out to accommodate the 1-½ inch thickness of the window frame’s lumber, adhered around the frame, and the OSB that overlapped the frame was secured to the edge of the 2x6 window box with framing nails. Figure 11 shows the installed window frame.

The 2x6 abutting the CMU wall was allowed to run wild above the window frame to serve as the edge seal on the panel that would be installed above the window. The edge sealer at the CMU wall, another 2x6, was pre-installed against a retrofit insulated panel in Figure 12. The panel was installed above the window in Figure 11 where the 2x6 was allowed to run wild.

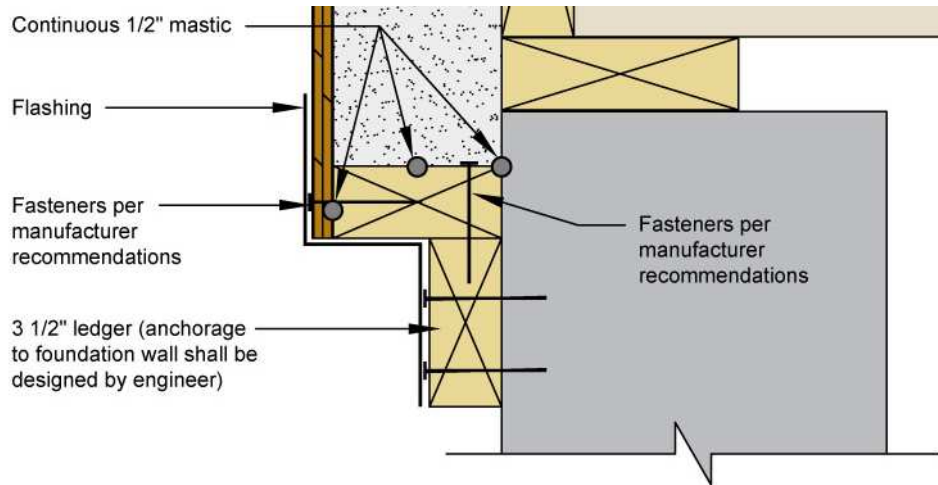
Figure 13. Typical Ledger Detail

The existing rear foundation masonry had been installed with a sloped profile at the outside grade in an attempt at dispelling rainwater from the foundation. Because of this, the ledger that carries the first retrofit panel and provides its edge seal had to be installed inverted to accommodate the condition and maximize the wall coverage. Figure 13 outlines the standard detail for ledger attachment.

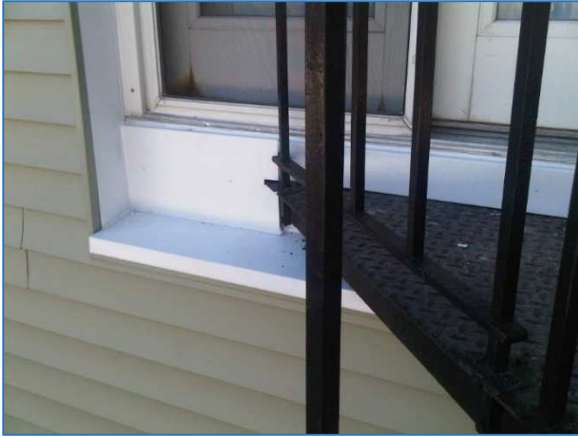
Figure 16. Patio Door Band Board behind Stair Landing Completed

Aerogel fabric was installed behind the rear stair landings underneath the patio doors to provide some additional thermal resistance and an air seal because the stair assembly could not be removed for access. The 10 mm thick fabric provides a thermal resistance of R-4 and is vapor permeable, but wind resistant, Figure 17. The material was installed at the band boards behind the rim of the metal stair landing and sealed around the lag bolts supporting the stair assembly, Figure. 18.

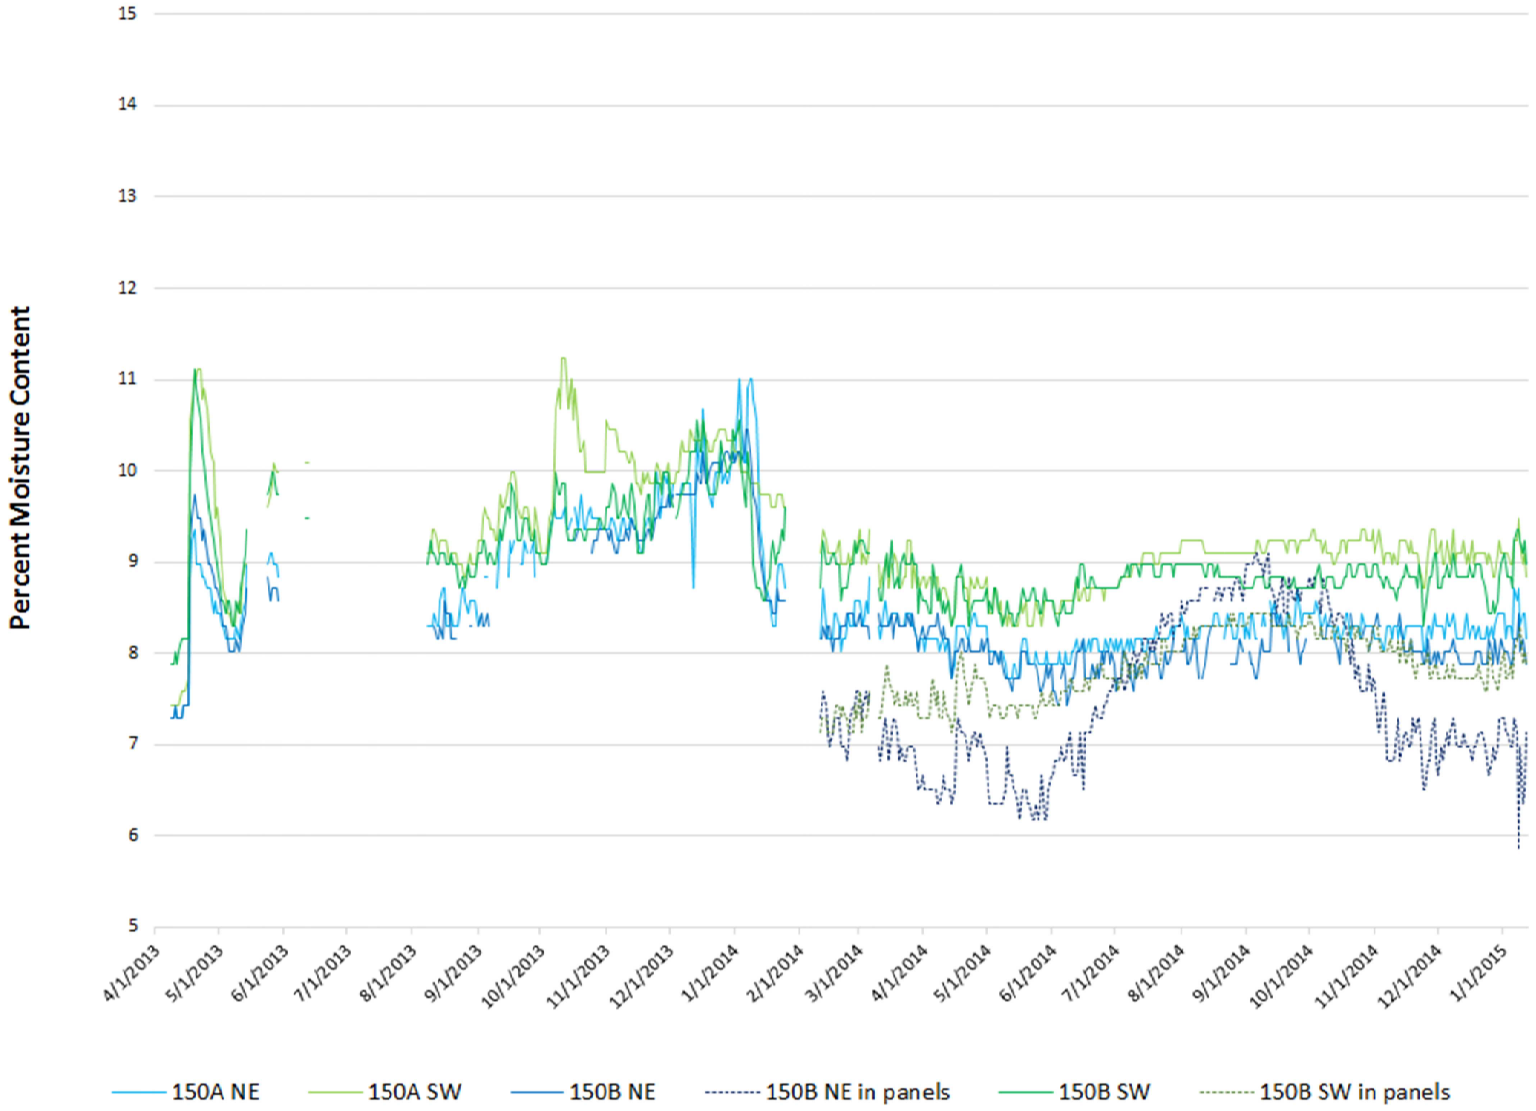
Figure 25. Moisture Content in Wall Cavities and Nailbase Panels – Units 150A & 150B

The manufacturer stated accuracy for the sensors is +/- 2.0% RH and +/- 0.3°C which has been verified by PHI researchers.¹⁴ Measurements of the wood moisture content (MC), by building sections of units between CMU walls, are reported by the graphs in Figures 25 – 27 which indicate average daily sheathing MC ranges generally between 6 and 11% with a few sensors reading slightly over 14% (Figure 26 covering the units in the middle of the building). The maximum MC recorded is well below the 20% minimum threshold that might indicate the start of wood fiber saturation,¹⁵ and is considered normal. There is a small but notable change in the existing wall sheathing MC from before the retrofit panel installation to after. Prior to the retrofit, the MC readings generally ranged from approximately 9% to less than 15% whereas following the retrofit, the MC readings fell to a range between 6% to less than 10%. This result implies that no negative moisture effects are indicated with the addition of the retrofit panels and the added insulation.

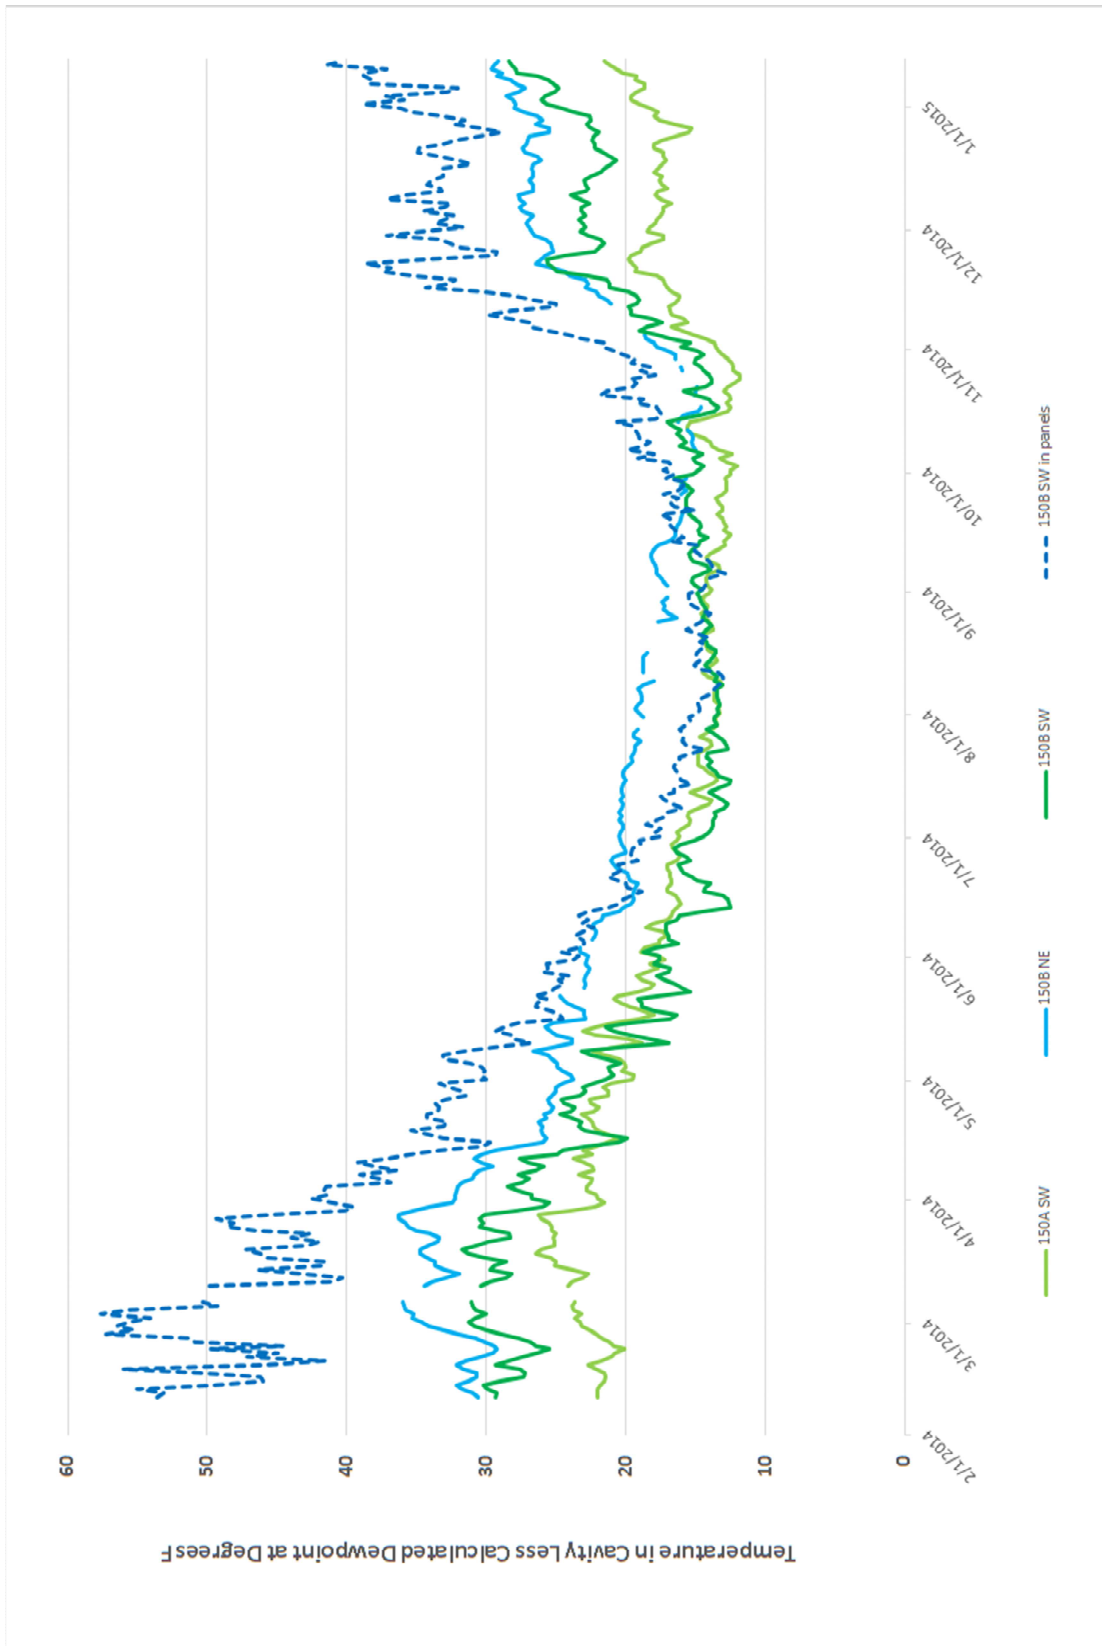
Figure 28. Condensation Potential – 150A & 150B

Moisture content will vary with ambient RH, the air tightness of the building and interior RH which makes RH another meaningful performance metric because as RH increases in a wall cavity the potential for condensation of water vapor on the outermost surface of OSB panels also increases. As relative humidity increases, the dew point temperature moves closer to the ambient temperature which makes RH a suitable metric for condensation potential. Comparison plots for the sensors located within the wall cavities and the temperature difference between the sheathing temperature and the dew point (DP) temperature are shown in Figures 28-30. Negative chart values (when the dew point temperature exceeds the sheathing temperature) would indicate a higher cavity DP than cavity air temperature near the OSB sheathing, with a resultant likelihood of condensation. This case was not noted in any of the wall panels or cavities.
